**Flood Control Project Maintenance
Levee Inspections**

Fall 2018 Levee Maintenance Deficiency Summary Report

Sacramento River Basin

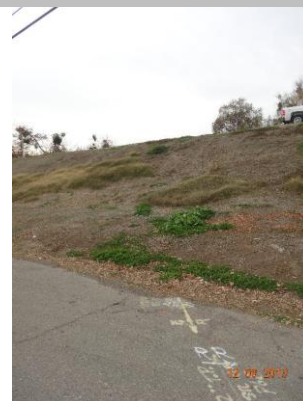
Photo 1 of 3 : UCIP_FA_2018_52686_53391.jpg

Item	DWR UCIP Field Study		38.600718 °	38.600718 °								
			-121.471491 °	-121.471491 °								
DWR ID	24648											
Comment Code												
Inspector Comment												
FS_ID:52686 DS_ID:24648 EP_NO: 911 Repair Type: Non-Urgent Crossing Status: Found UCIP Comments: 08/11/2017 PG&E records for DFM 0613-01 indicate that there were no observations found on the 07/2017 patrol, no leaks found on the 05/2017 leak survey, and the pipeline is operating correctly according to the 04/2017 CP inspection. ECDA in 2015; this integrity assessment identified no issues requiring corrective action. ILI in 2016; all corrective actions identified in this integrity assessment have been resolved. (DWR UCIP - A. McDonald)8/11/2016 Markers found on WS. No markers found on LS. Crossing has been downgraded from Urgent to Non-Urgent, pipe has been marked on WS only. (DWR UCIP - omagana)2/6/2015 Permit information was entered and crossing description updated. (DWR UCIP - omagana)12/3/13 Need to contact owner to determine status of crossing. Markers missing. (DWR UCIP - omagana) FIELD_STRUCT_DESC: 12.75-inch gas line of unknown material through the levee at unknown depth. Markers found on the waterside (WS) approximately 192 feet and 410 feet from levee crown. No markers found on landside (LS). In case of an emergency related to this pipeline, PG&E has identified the following contacts: PG&E's local pipeline engineer, Mike Aronoff at 916-307-9472 (cell), and Gas Control (north) at 800-442-4743. For non-emergency issues, please contact the local PG&E Gas Pipeline Operations and Maintenance (GPOM) supervisors for the Sacramento region, David Wade at 209-639-1039 (cell), or Ron Hicks at 916-396-9038 (cell). (12.75-inch line installed under Permit No. 911, 1943 - Pacific Gas and Electric Company [PG&E]) FS Date: 8/11/2016

View of LS slope and USA paint markings indicating alignment.

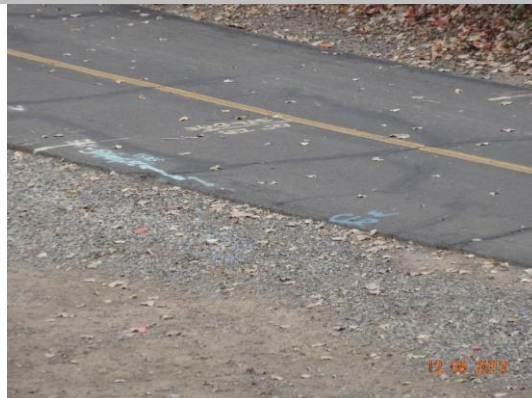
Photo 2 of 3 : UCIP_FA_2018_52686_53390.jpg

Underground service alert (USA) approximate alignment for 12-inch gas line through levee and WS--USA markings on bike path.

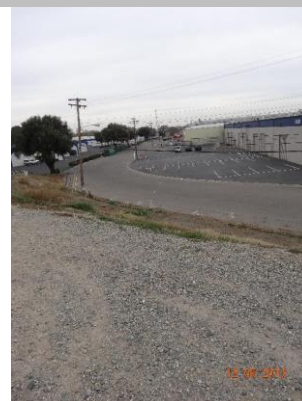
Photo 3 of 3 : UCIP_FA_2018_52686_53389.jpg

View of LS with undergroundservice alert (USA) paint with approximate alignment of multiple crossing in general area.

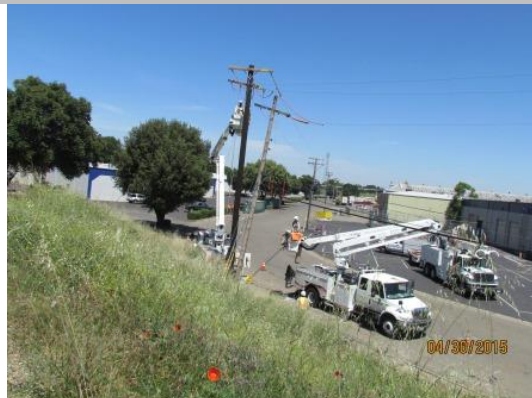
Photo 1 of 1 : FA_2018_NA0001_490_24_20180911_00001.jpg

LM Start	3.31	Rating **	M	Issue No.	24
LM End	3.31	Issue Type +	En	Location *	LS
Category	Earthen Levee			GPS Latitude/Longitude	
				Start	End
Item	Encroachments			38.600958 °	38.600958 °
				-121.471618 °	-121.471618 °
DWR ID	DWR_NA0001_03_s_2015_24				
Comment Code					
PO : Pole					
Inspector Comment					
SMUD replacing old pole at the landside toe of the levee. Pole line does not appear to be permitted.

View of a new pole installed at the landside levee toe. Spring 2015

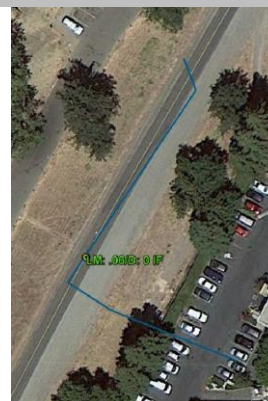
Photo 1 of 3 : UCIP_FA_2018_29003_53405.jpg

LM Start	0.06	Rating **	M	Issue No.	746
LM End	0.06	Issue Type +	En	Location *	
Category	Supplemental			GPS Latitude/Longitude	
				Start	End
Item	DWR UCIP Field Study			38.597198 °	38.597198 °
				-121.506532 °	-121.506532 °
DWR ID	24344				
Comment Code					
Inspector Comment					
FS_ID:29003 DS_ID:24344 EP_NO: N/A Repair Type: Non-Urgent Crossing Status: Indicator Found UCIP Comments: Metal boxes located on landward side could be associated with utility -- unable to confirm. Will need to contact owner. FIELD_STRUCT_DESC: Electrical conduit of unknown material through the levee at unknown depth. FS Date: 12/19/2013

Approximate alignment provided by the City of Sacramento for 2 inch line. Point labelled in green is field verified location where signs of crossing exist.

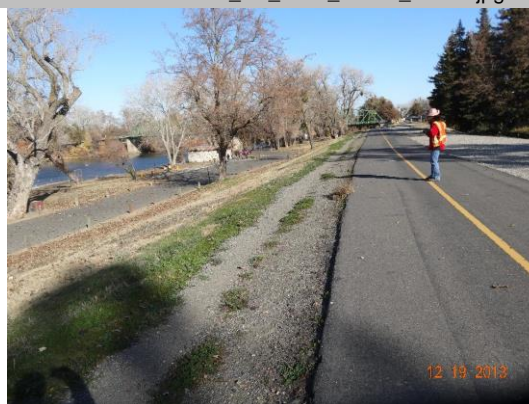
Photo 2 of 3 : UCIP_FA_2018_29003_53404.jpg

Overview of levee crown and waterward side.

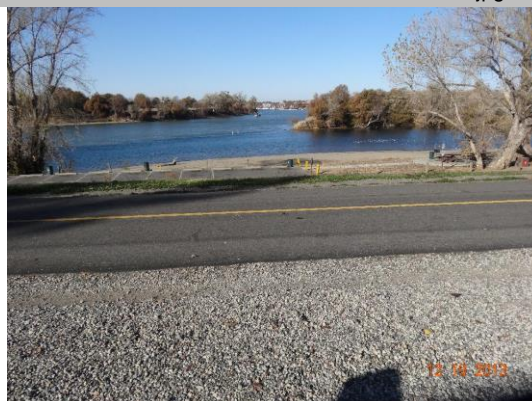
Photo 3 of 3 : UCIP_FA_2018_29003_53402.jpg

View of waterward side.

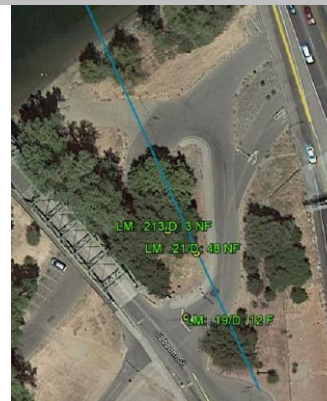
Photo 1 of 1 : UCIP_FA_2018_29006_53414.jpg

LM Start	0.21	Rating **	M	Issue No.	747	
LM End	0.21	Issue Type +	En	Location *		
Category	Supplemental			GPS Latitude/Longitude		
				Start		End
Item	DWR UCIP Field Study			38.598982 °		38.598982 °
				-121.505045 °		-121.505045 °
DWR ID	24435					
Comment Code						
Inspector Comment						
FS_ID:29006 DS_ID:24435 EP_NO: 17171 Repair Type: Non-Urgent Crossing Status: Not Found UCIP Comments: Unable to find any indications that crossing is still active. Will need to contact owner to determine status of crossing. FIELD_STRUCT_DESC: 48-inch steel water line through the levee, approximately 32 feet below the crown. Siphon and blowoff valves in concrete riser on the landside (LS). (48-inch water transmission main authorized under Permit No. 17171, 2001-City of Sacramento, Department of Utilities) FS Date: 12/19/2013

Approximate alignment provided by the City of Sacramento--crossing not found during field visit.

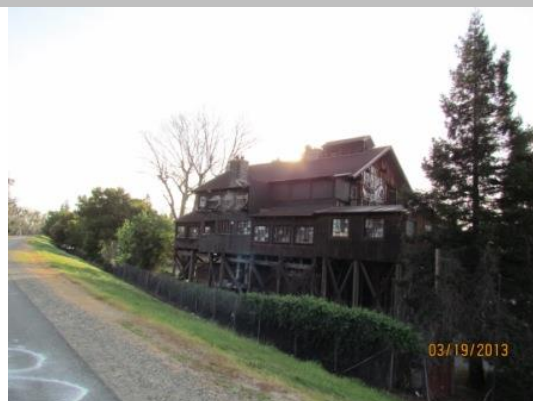
Photo 1 of 1 : FA_2018_NA0001_55_1_20180911_00001.jpg

LM Start	0.31	Rating **	M	Issue No.	1
LM End	0.45	Issue Type +	En	Location *	LS
Category	Earthen Levee			GPS Latitude/Longitude	
				Start	End
Item	Vegetation			38.599835 °	38.600769 °
				-121.503448 °	-121.501133 °
DWR ID	DWR_NA0001_04_s_2012_1				
Comment Code					
V6 : Landscaping					
Inspector Comment					
Vines and privacy fence within 10-ft of the landside toe or on the levee slope obstruct visibility and access.

View of the vines obstructing visibility.

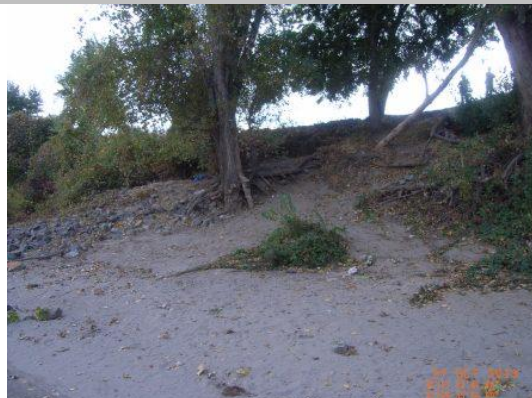
Photo 1 of 1 : FA_2018_NA0001_55_214_20181105_00136.jpg

LM Start	1.49	Rating **	M	Issue No.	214
LM End	1.65	Issue Type +	Ma	Location *	WS
Category	Supplemental			GPS Latitude/Longitude	
				Start	End
Item	2017 USACE Erosion Survey, DRAFT			38.599878 °	38.598791 °
				-121.482483 °	-121.479799 °
DWR ID	DWR_NA0001_04_f_2018_214				
Comment Code					
Inspector Comment					
2017 Site ID: LAR 1.8 L					
Status: Eroding					
2017 Field Notes: Site littered with homeless camps. Hard to survey. Site extended downstream.					
Site History: 2012 - Located just downstream of older repair. Failing rock at the upstream end. Erosion of the bank has exposed large tree roots.

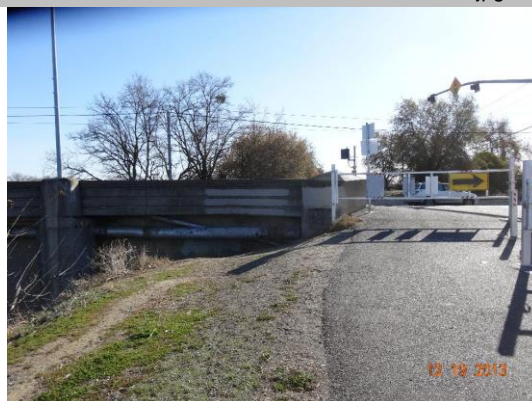
Photo 1 of 3 : UCIP_FA_2018_53493_53496.jpg

UCIP Comments: 07/18/2018 Besides the holes found in the sewer pipe, everything appears to be the same. Crossing remains "Urgent" due to the holes in the line. There could also be pipe integrity issues under the levee. Since this is an abandoned sewer line, recommend that this pipe be abandoned properly to eliminate any threats to the pipe or the levee. (DWR UCIP - A. McDonald)08/29/2017 After reviewing record dsid 24625, record dsid 24625 appears to be the same record as this entry, dsid 24307. The information from dsid 24625, has been transferred to this entry. The old record will be retired from the UCIP list and considered a duplicate record. This record has been updated to reflect record source origins from both DWR Levee Logs, referenced as a 20-inch pipe, and the USACE O&M manual, 18-inch pipe. (DWR UCIP - O. Magana)

8/11/2016 Crossing was classified incorrectly. Crossing is not a gas line. This crossing appears to be an abandoned sewer line. On WS, holes are present on the pipe wall and visible cracks are found on the concrete wall where pipe crosses. According to LMA, Tim Kerr and Richard Marck, this crossing could be a City line. Need to find owner and determine fate of crossing. Owner will need to coordinate with CVFPB to comply with Title 23. (DWR UCIP - omagana)12/19/2013 No markers or labels visible to indicate line is gas line--unable to confirm. (DWR UCIP - omagana)

FIELD_STRUCT_DESC: *ABANDONED* 18-inch (not 20-inch as referenced in the DWR Levee Log) wrapped steel sewer pipe through the levee, 5 feet below the crown. The 20-inch pipe was initially referenced as a 20-inch gas line under DWR levee logs that dated back to 1956. During the 2016 inspection, the pipe was identified (field measured) as an 18-inches non-gas line. The sewer pipe has holes in it. It appears that this crossing has been mislabeled or replaced. No additional information was found. This sewer pipe is not in use and needs to be abandoned properly or removed. [Additional Reference(s): DWR Levee Log, 1956 and 2002. USACE Sacramento O&M Manual Unit 118 Part 1, August 1955, (Station 89+28)].

View of line exposed at the bridge.

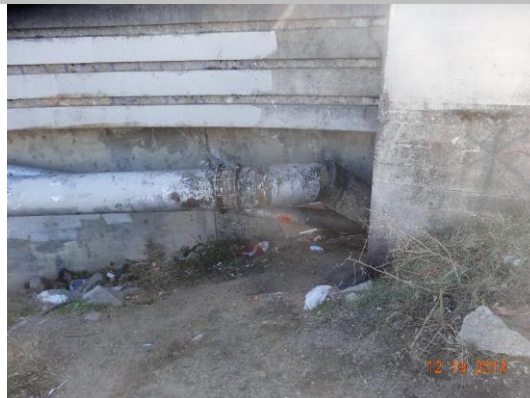
Photo 2 of 3 : UCIP_FA_2018_53493_53495.jpg

Two crossings visible at bridge.

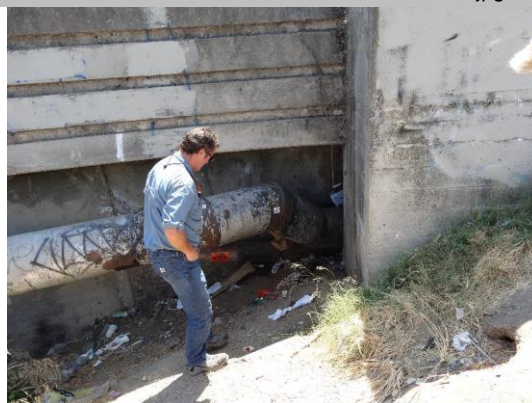
Photo 3 of 3 : UCIP_FA_2018_53493_75833.jpg

8/11/2016 Crossing was classified incorrectly. Crossing is not a gas line. This crossing appears to be an abandoned sewer line. On WS, holes are present on the pipe wall and visible cracks are found on the concrete wall where pipe crosses. According to LMA, Tim Kerr and Richard Marck, this crossing could be a City line. Need to find owner and determine fate of crossing. Owner will need to coordinate with CVFPB to comply with Title 23. (DWR UCIP - omagana)12/19/2013 No markers or labels visible to indicate line is gas line--unable to confirm. (DWR UCIP - omagana)

18-inch abandoned line and 8-inch gas line visible on WS.

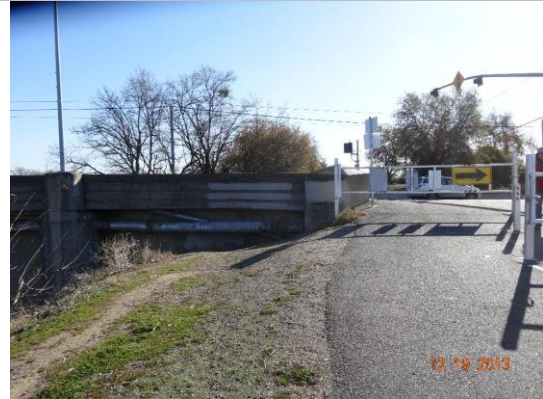
Photo 1 of 3 : UCIP_FA_2018_52685_55422.jpg

FS_ID:52685
DS_ID:24528
EP_NO: N/A
Repair Type: Non-Urgent
Crossing Status: Found
UCIP Comments: 08/29/2017 After reviewing record dsid 24492, record dsid 24492 appears to be the same record as this entry, dsid 24528. The information from dsid 24492, has been transferred to this entry. The old record will be retired from the UCIP list and considered a duplicate record. This record has been updated to reflect record source origins from both DWR Levee Logs, referenced as a 10-inch pipe, and the USACE O&M manual, 8-inch pipe. PG&E refers to this line as DFM 0613-01. (DWR UCIP - O. Magana)
08/16/2017 --previously noted under dsid 24492-- DWR Deferred Maintenance Project (DMP), Vince Rodriguez, forwarded email received from Tim Kerr, General Manager of American River Flood Control District (ARFCD) with file "DWR Eligible Pipes Found in ARFCD" from ARFCD that shows the ownership and location of the pipes Tim Kerr investigated. No owner was identified, ARFCD Staff Notes indicate listed as Not Found in UCIP - Steel Pipe on Bridge??. (DWR UCIP - O. Magana)

Utility lines through levee and across channel.

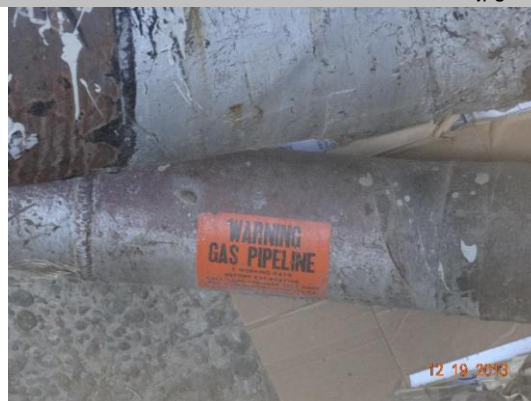
Photo 3 of 3 : UCIP_FA_2018_52685_55420.jpg

Label found on smaller pipe at bridge.

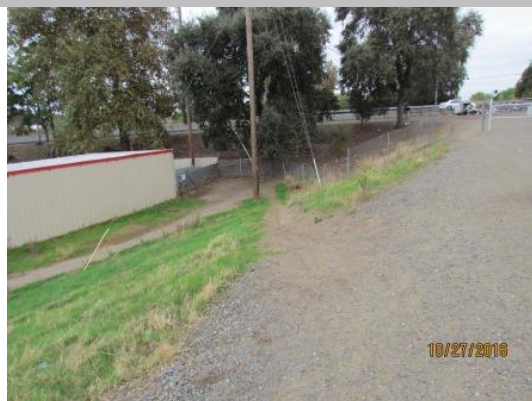
Photo 1 of 1 : FA_2018_NA0001_55_244_20180911_00196.jpg

LM Start	1.95	Rating **	A/W	Issue No.	244
LM End	1.95	Issue Type +	Ma	Location *	LS
Category	Earthen Levee			GPS Latitude/Longitude	
				Start	End
Item	Slope Stability			38.595040 °	38.595040 °
				-121.476882 °	-121.476882 °
DWR ID	DWR_NA0001_04_f_2015_244				
Comment Code					
S2 : Repair the levee slope damaged by foot traffic and prevent access where possible.					
Inspector Comment					
The erosion of the levee slope from the footpath appears to be stable at this time and should be monitored.

View of the footpath on the landside levee slope. Fall 2016

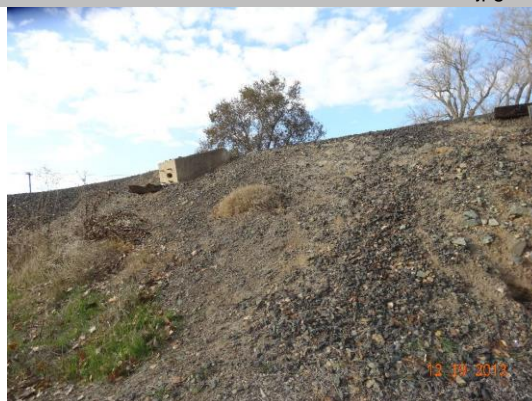
Photo 1 of 3 : UCIP_FA_2018_29927_55259.jpg

LM Start	2.25	Rating **	M	Issue No.	751
LM End	2.25	Issue Type +	En	Location *	
Category	Supplemental			GPS Latitude/Longitude	
				Start	End
Item	DWR UCIP Field Study			38.591923°	38.591923°
				-121.473744°	-121.473744°
DWR ID	24310				
Comment Code					
Inspector Comment					
FS_ID:29927 DS_ID:24310 EP_NO: 14150 Repair Type: Non-Urgent Crossing Status: Indicator Found UCIP Comments: unable to confirm if crossing is 4-inch steel conduit--will need to coordinate with owner. FIELD_STRUCT_DESC: 4-inch galvanized iron communication conduit containing fiber optic cables through the levee, 3.5 feet below the crown. Markers on the levee shoulder. Rock revetment on the waterside (WS) slope. (4-inch galvanized iron pipe authorized under Permit No. 14150, 1986-MCI Telecommunication Corp.) [Additional Reference(s): DWR Levee Log, 2002] FS Date: 12/19/2013

View of waterward slope--concrete box could be associated with conduit?

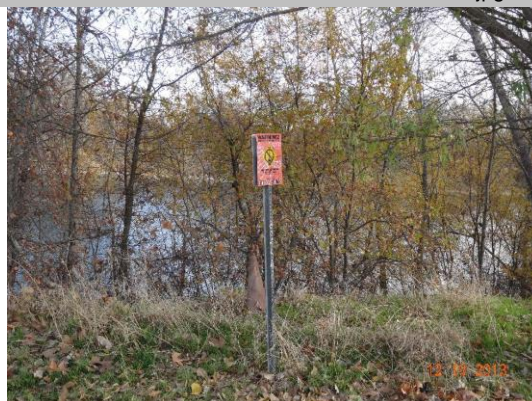
Photo 2 of 3 : UCIP_FA_2018_29927_55261.jpg

Marker for buried fiber optic cable on waterward side.

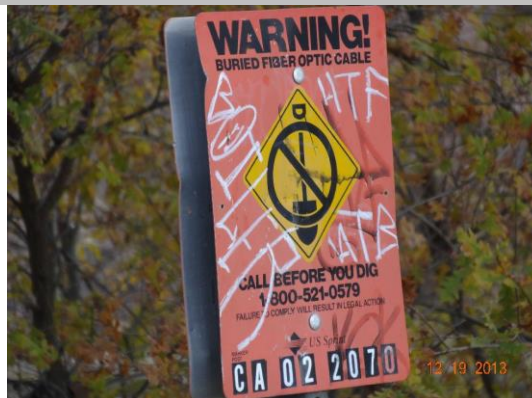
Photo 3 of 3 : UCIP_FA_2018_29927_55260.jpg

Contact information for US Sprint--not MCI as records indicate.

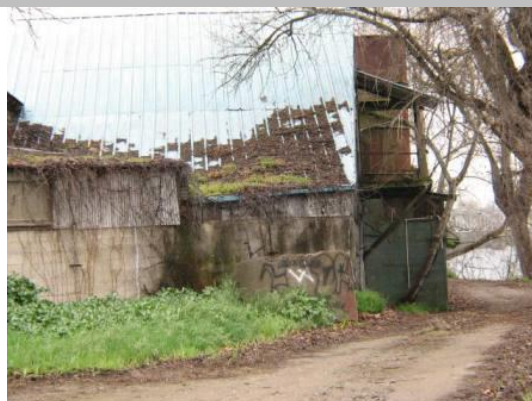
Photo 1 of 1 : FA_2018_NA0001_55_2_20180911_00002.jpg

LM Start	2.68	Rating **	U	Issue No.	2
LM End	2.68	Issue Type +	En	Location *	LS
Category	Earthen Levee			GPS Latitude/Longitude	
				Start	End
Item	Encroachments			38.588913 °	38.588913 °
				-121.467210 °	-121.467210 °
DWR ID	DWR_NA0001_04_s_2012_2				
Comment Code					
BU : Building					
Inspector Comment					
Bell Marine structure encroaches levee easement.

03/16/2012 Structure on Bell Marine property.

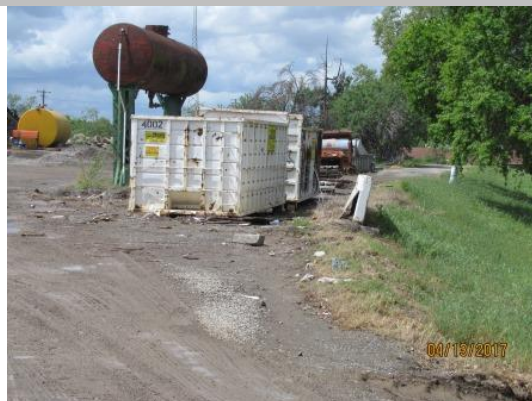
Photo 1 of 2 : FA_2018_NA0001_55_3_20180911_00003.jpg

LM Start	2.72	Rating **	U	Issue No.	3
LM End	2.86	Issue Type +	En	Location *	LS
Category	Earthen Levee			GPS Latitude/Longitude	
				Start	End
Item	Encroachments			38.587939 °	38.587299 °
				-121.466635 °	-121.464320 °
DWR ID	DWR_NA0001_04_s_2012_3				
Comment Code					
EQ : Equipment					
Inspector Comment					
Bell Marine, LMA sent a letter to property owner for the violation. Equipment completely blocks levee crown.

View of the equipment obstructing levee crown access. Spring 2017.

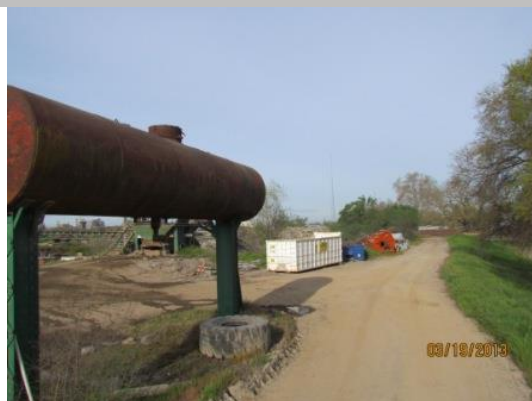
Photo 2 of 2 : FA_2018_NA0001_55_3_20180911_00004.jpg

LM Start	2.72	Rating **	U	Issue No.	3 (cont)	
LM End	2.86	Issue Type +	En	Location *	LS	
Category	Earthen Levee			GPS Latitude/Longitude		
				Start	End	
Item	Encroachments			38.587939 °	38.587299 °	
				-121.466635 °	-121.464320 °	
DWR ID	DWR_NA0001_04_s_2012_3					
Comment Code						
EQ : Equipment						
Inspector Comment						
Bell Marine, LMA sent a letter to property owner for the violation. Equipment completely blocks levee crown.

View of the debris obstructing visibility and access.

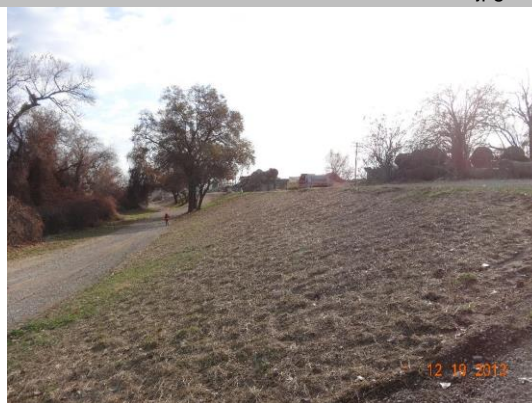
Photo 1 of 2 : UCIP_FA_2018_31444_57486.jpg

LM Start	2.77	Rating **	M	Issue No.	753
LM End	2.77	Issue Type +	En	Location *	
Category	Supplemental			GPS Latitude/Longitude	
				Start	End
Item	DWR UCIP Field Study			38.587629 °	38.587629 °
				-121.465905 °	-121.465905 °
DWR ID	24805				
Comment Code					
Inspector Comment					
FS_ID:31444					
DS_ID:24805					
EP_NO: N/A					
Repair Type: Non-Urgent					
Crossing Status: Indicator Found					
UCIP Comments: No permit (unauthorized crossing)--need additional information about crossing.					
FIELD_STRUCT_DESC: Standpipe located on waterside (WS) shoulder. Unable to confirm pipe alignment. No permit found.					
FS Date: 12/19/2013

View of waterward slope.

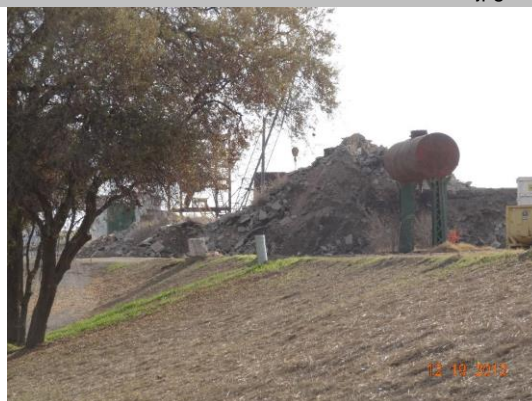
Photo 2 of 2 : UCIP_FA_2018_31444_57485.jpg

LM Start	2.77	Rating **	M	Issue No.	753 (cont)
LM End	2.77	Issue Type +	En	Location *	
Category	Supplemental			GPS Latitude/Longitude	
				Start	End
Item	DWR UCIP Field Study			38.587629 °	38.587629 °
				-121.465905 °	-121.465905 °
DWR ID	24805				
Comment Code					
Inspector Comment					
FS_ID:31444 DS_ID:24805 EP_NO: N/A Repair Type: Non-Urgent Crossing Status: Indicator Found UCIP Comments: No permit (unauthorized crossing)--need additional information about crossing. FIELD_STRUCT_DESC: Standpipe located on waterside (WS) shoulder. Unable to confirm pipe alignment. No permit found. FS Date: 12/19/2013

Standpipe located on waterward shoulder.

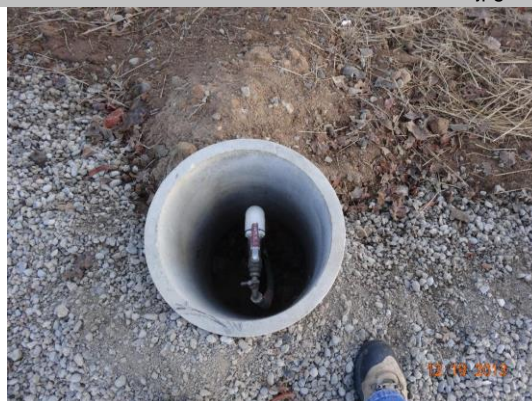
Photo 1 of 1 : UCIP_FA_2018_31445_57487.jpg

LM Start	2.82	Rating **	M	Issue No.	755	
LM End	2.82	Issue Type +	En	Location *		
Category	Supplemental			GPS Latitude/Longitude		
				Start	End	
Item	DWR UCIP Field Study			38.587438 °	38.587438 °	
				-121.464989 °	-121.464989 °	
DWR ID	24806					
Comment Code						
Inspector Comment						
FS_ID:31445						
DS_ID:24806						
EP_NO: N/A						
Repair Type: Non-Urgent						
Crossing Status: Found						
UCIP Comments: No permit found (unauthorized?)--need additional information about crossing.						
FIELD_STRUCT_DESC: Standpipe located on waterside (WS) shoulder. Pipe crosses levee crown and landside (LS). Pipe used for irrigation. No Permit found.						
FS Date: 12/13/2013

Spigot located inside riser located on waterward shoulder.

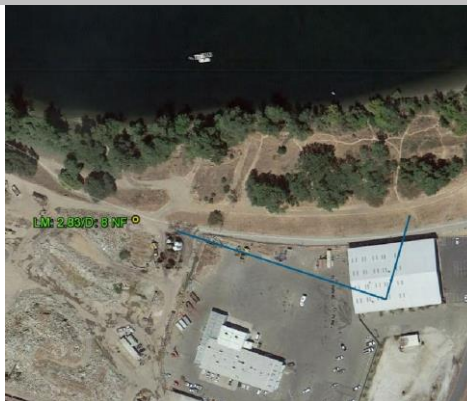
Photo 1 of 1 : UCIP_FA_2018_31253_57216.jpg

Comment Code					
Inspector Comment					
FS_ID:31253 DS_ID:24328 EP_NO: 5890 Repair Type: Non-Urgent Crossing Status: Not Found UCIP Comments: Need to contact owner to determine status of crossing--approximate alignment indicates pipe does not cross levee however records shows drain pipe crosses levee. FIELD_STRUCT_DESC: 8-inch corrugated metal drainage pipe through the levee, 2.1 feet below the crown. Concrete drop inlet structure at waterside (WS) shoulder. Maintenance facilities and yard on the landside (LS). Rock revetment on WS slope. (8-inch pipe authorized under Permit No. 5890, 1968 - City of Sacramento) [Additional Reference(s): DWR Levee Log, 2002. USACE Sacramento O&M Manual Unit 118 Part 1, August 1955, (Station 156+75)]. FS Date: 12/19/2013

Approximate alignment indicated in blue and approximate location indicated by DWR-UCIP in green label.

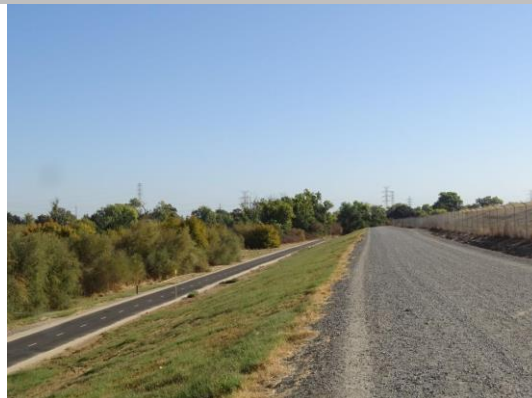
Photo 1 of 1 : FA_2018_NA0001_55_215_20181024_00264.jpg

LM Start	2.96	Rating **	A	Issue No.	215
LM End	3.68	Issue Type +	Ma	Location *	WS
Category	Earthen Levee			GPS Latitude/Longitude	
				Start	End
Item	Vegetation			38.588625 °	38.588295 °
				-121.458491 °	-121.450511 °
DWR ID	DWR_NA0001_04_f_2018_215				
Comment Code					
V1 : Control annual grass and weeds on the levee slopes and easements.					
Inspector Comment					
Vegetation is well maintained.

View of waterside vegetation. Fall 2018

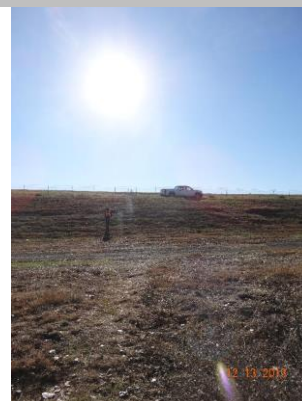
Photo 1 of 3 : UCIP_FA_2018_31254_57217.jpg

Comment Code						
Inspector Comment						
FS_ID:31254 DS_ID:24330 EP_NO: 15041 Repair Type: Non-Urgent Crossing Status: Indicator Found UCIP Comments: 08/16/2017 DWR Deferred Maintenance Project (DMP), Vince Rodriguez, forwarded email received from Tim Kerr, General Manager of American River Flood Control District (ARFCD) with file "DWR Eligible Pipes Found in ARFCD" from ARFCD that shows the ownership and location of the pipes Tim Kerr investigated. Owner of this crossing is identified as the City of Sacramento, ARFCD Staff Notes indicate landfill drain pipe (Permit# 15041) id#3424. (DWR UCIP - O. Magana) 12/13/2013 Hole present on riser located on landward side--contact owner. Additional pipe found in waterward berm. Unable to confirm if this pipe section is part of crossing--size does not match. Unable to find CM standpipe on waterward side. (DWR UCIP - O. Magana) FIELD_STRUCT_DESC: 18-inch corrugated metal drainage pipe through the levee at an unknown depth. Steel cutoff wall around pipe at center of levee. Storm drain gate on landside (LS) shoulder. Drainage ditch on LS. Corrugated metal standpipe on waterside (WS). Rock-filled ditch on WS. (18-inch pipe authorized under Permit No. 15041, 1993 - City of Sacramento) [Additional Reference(s): DWR Levee Log, 2002] FS Date: 12/13/2013

Overview of waterward side.

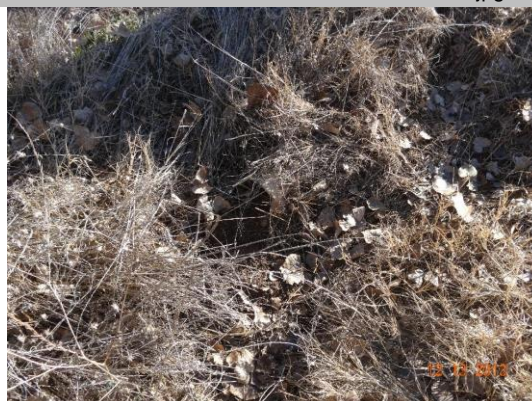
Photo 2 of 3 : UCIP_FA_2018_31254_57219.jpg

Comment Code						
Inspector Comment						
FS_ID:31254 DS_ID:24330 EP_NO: 15041 Repair Type: Non-Urgent Crossing Status: Indicator Found UCIP Comments: 08/16/2017 DWR Deferred Maintenance Project (DMP), Vince Rodriguez, forwarded email received from Tim Kerr, General Manager of American River Flood Control District (ARFCD) with file "DWR Eligible Pipes Found in ARFCD" from ARFCD that shows the ownership and location of the pipes Tim Kerr investigated. Owner of this crossing is identified as the City of Sacramento, ARFCD Staff Notes indicate landfill drain pipe (Permit# 15041) id#3424. (DWR UCIP - O. Magana) 12/13/2013 Hole present on riser located on landward side--contact owner. Additional pipe found in waterward berm. Unable to confirm if this pipe section is part of crossing--size does not match. Unable to find CM standpipe on waterward side. (DWR UCIP - O. Magana) FIELD_STRUCT_DESC: 18-inch corrugated metal drainage pipe through the levee at an unknown depth. Steel cutoff wall around pipe at center of levee. Storm drain gate on landside (LS) shoulder. Drainage ditch on LS. Corrugated metal standpipe on waterside (WS). Rock-filled ditch on WS. (18-inch pipe authorized under Permit No. 15041, 1993 - City of Sacramento) [Additional Reference(s): DWR Levee Log, 2002] FS Date: 12/13/2013

Pipe buried by vegetation--unable to determine if pipe goes through levee.

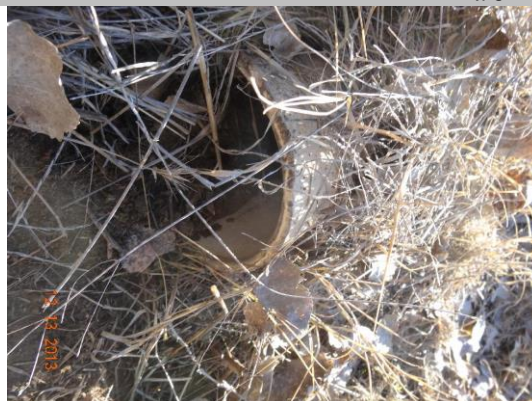
Photo 3 of 3 : UCIP_FA_2018_31254_57221.jpg

Pipe buried through vegetation.

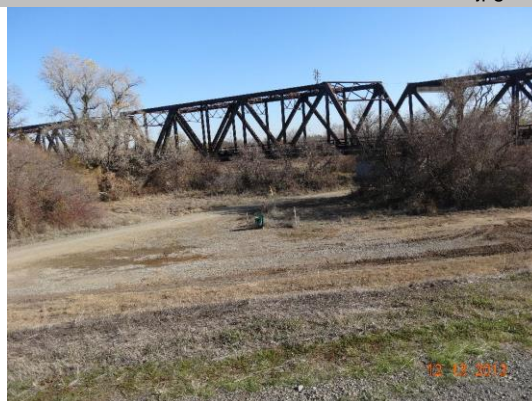
Photo 1 of 3 : UCIP_FA_2018_42128_56573.jpg

Comment Code						
Inspector Comment						
FS_ID:42128 DS_ID:24807 EP_NO: N/A Repair Type: Non-Urgent Crossing Status: Indicator Found UCIP Comments: 11/3/2014 (DWR-Olivia) Need to contact owner to determine status of crossing. Priority under Part IX has been changed from Urgent to Non-Urgent as a measure to normalize the data. Per Title 23 markers are necessary for pressure line--markers present. Recommend LMA to contact owner to determine additional information details--CVFPB permit, depth of pipe through levee, alignment, and last inspection completed confirming integrity of crossing.No permit found. Will need to contact owner to determine the status of crossing. FIELD_STRUCT_DESC: Petroleum line of unknown material or size through the levee, at an unknown depth. Markers visible on waterside (WS). Unable to confirm alignment. Markers provide Kinder Morgan (Owner) contact information - for emergencies contact 916-363-1666. FS Date: 12/13/2013

View of waterward side.

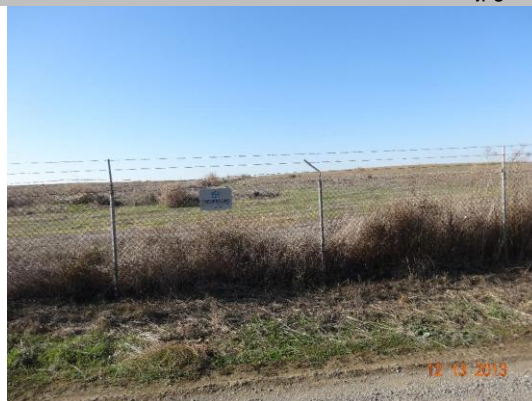
Photo 2 of 3 : UCIP_FA_2018_42128_56572.jpg

View of landward side.

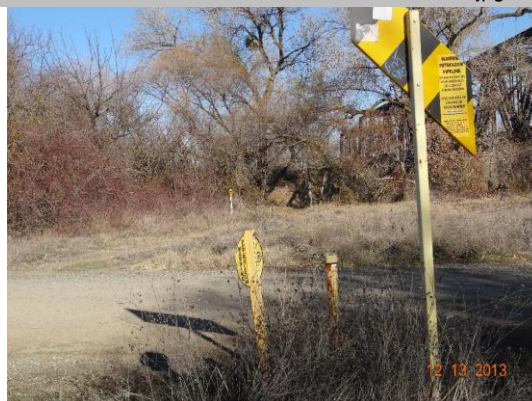
Photo 3 of 3 : UCIP_FA_2018_42128_56576.jpg

Comment Code						
Inspector Comment						
FS_ID:42128 DS_ID:24807 EP_NO: N/A Repair Type: Non-Urgent Crossing Status: Indicator Found UCIP Comments: 11/3/2014 (DWR-Olivia) Need to contact owner to determine status of crossing. Priority under Part IX has been changed from Urgent to Non-Urgent as a measure to normalize the data. Per Title 23 markers are necessary for pressure line--markers present. Recommend LMA to contact owner to determine additional information details--CVFPB permit, depth of pipe through levee, alignment, and last inspection completed confirming integrity of crossing.No permit found. Will need to contact owner to determine the status of crossing. FIELD_STRUCT_DESC: Petroleum line of unknown material or size through the levee, at an unknown depth. Markers visible on waterside (WS). Unable to confirm alignment. Markers provide Kinder Morgan (Owner) contact information - for emergencies contact 916-363-1666. FS Date: 12/13/2013

View of markers visible on landward side.

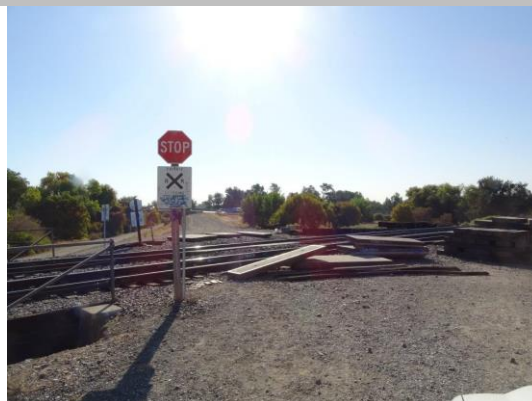
Photo 1 of 2 : FA_2018_NA0001_55_216_20181024_00265.jpg

LM Start	3.68	Rating **	U	Issue No.	216
LM End	3.68	Issue Type +	En	Location *	CR
Category	Earthen Levee			GPS Latitude/Longitude	
				Start	End
Item	Encroachments			38.588295 °	38.588295 °
				-121.450508 °	-121.450508 °
DWR ID	DWR_NA0001_04_f_2018_216				
Comment Code					
EQ : Equipment					
Inspector Comment					
Railroad platforms were removed from crossing and block crown access.

View of railroad debris on levee crown. Fall 2018

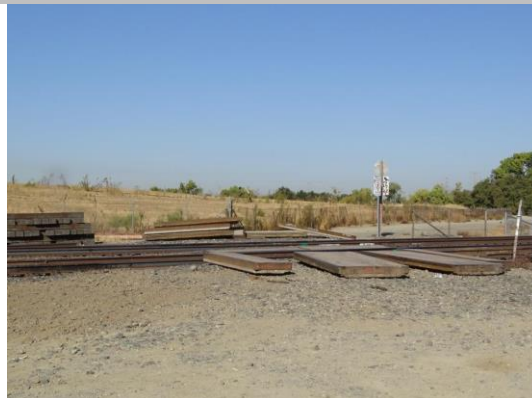
Photo 2 of 2 : FA_2018_NA0001_55_216_20181024_00266.jpg

LM Start	3.68	Rating **	U	Issue No.	216 (cont)	
LM End	3.68	Issue Type +	En	Location *	CR	
Category	Earthen Levee			GPS Latitude/Longitude		
				Start		End
Item	Encroachments			38.588295 °	38.588295 °	
				-121.450508 °	-121.450508 °	
DWR ID	DWR_NA0001_04_f_2018_216					
Comment Code						
EQ : Equipment						
Inspector Comment						
Railroad platforms were removed from crossing and block crown access.

View of railroad debris on levee crown. Fall 2018

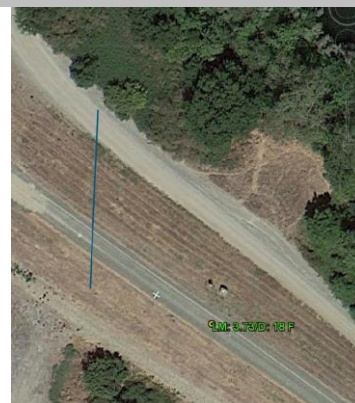
Photo 1 of 3 : UCIP_FA_2018_31255_57226.jpg

LM Start	3.75	Rating **	M	Issue No.	759
LM End	3.75	Issue Type +	En	Location *	
Category	Supplemental			GPS Latitude/Longitude	
				Start	End
Item	DWR UCIP Field Study			38.587724 °	38.587724 °
				-121.449554 °	-121.449554 °
DWR ID	24335				
Comment Code					
Inspector Comment					
FS_ID:31255 DS_ID:24335 EP_NO: N/A Repair Type: Non-Urgent Crossing Status: Found UCIP Comments: Control box is non-functional parts have been removed. Unable to confirm diameter size and status--City of Sacramento incidates a 24 inch sewer main not 18 inch. Need to contact owner to confirm size. FIELD_STRUCT_DESC: 18-inch sewer main through the levee. Concrete manhole on the waterside (WS) slope. [Additional Reference(s): DWR Levee Log, 2002] FS Date: 12/13/2013

Approximate alignment provided by City of Sacramento and DWR-UCIP confirmed location of sewer line is indicated by green label.

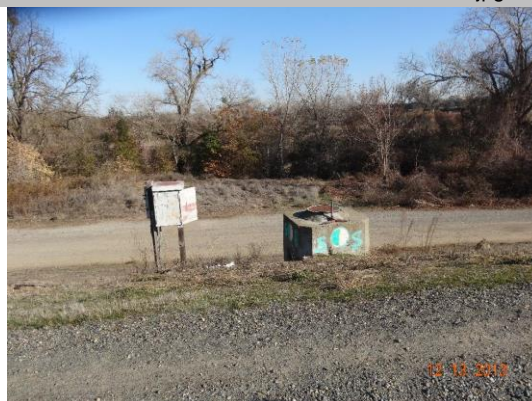
Photo 2 of 3 : UCIP_FA_2018_31255_57223.jpg

LM Start	3.75	Rating **	M	Issue No.	759 (cont)	
LM End	3.75	Issue Type +	En	Location *		
Category	Supplemental			GPS Latitude/Longitude		
				Start	End	
Item	DWR UCIP Field Study			38.587724 °	38.587724 °	
				-121.449554 °	-121.449554 °	
DWR ID	24335					
Comment Code						
Inspector Comment						
FS_ID:31255 DS_ID:24335 EP_NO: N/A Repair Type: Non-Urgent Crossing Status: Found UCIP Comments: Control box is non-functional parts have been removed. Unable to confirm diameter size and status--City of Sacramento incitates a 24 inch sewer main not 18 inch. Need to contact owner to confirm size. FIELD_STRUCT_DESC: 18-inch sewer main through the levee. Concrete manhole on the waterside (WS) slope. [Additional Reference(s): DWR Levee Log, 2002] FS Date: 12/13/2013

View of waterward side.

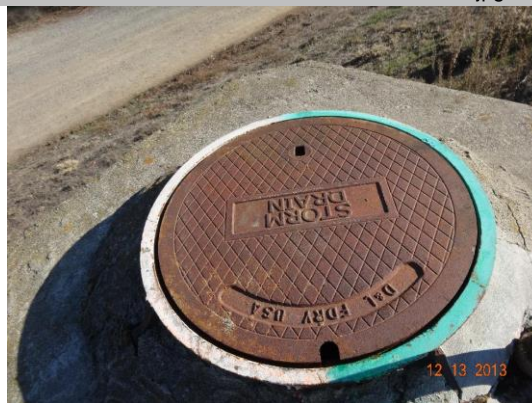
Photo 3 of 3 : UCIP_FA_2018_31255_57222.jpg

Manhole located on waterward slope.

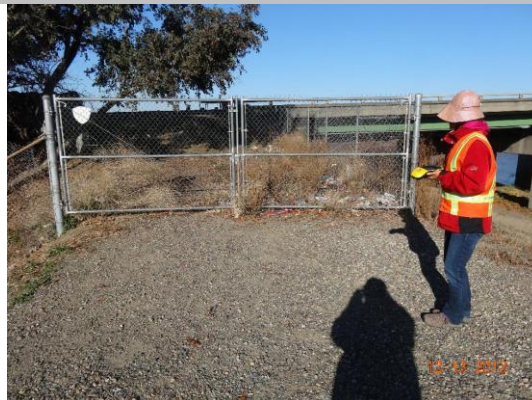
Photo 1 of 3 : UCIP_FA_2018_52708_55292.jpg

FS_ID:52708
DS_ID:24311
EP_NO: 2805
Repair Type: Non-Urgent
Crossing Status: Indicator Found
UCIP Comments: 07/18/2018 Everything appears to be the same as last time. No changes have been made. (A. McDonald - DWR UCIP)08/11/2016 Inspected the crossing with Tim Kerr and Richard Marck, LMA representatives, and it appears that this crossing is not the correct location. The odor could be due to a sewer clean out located on LS toe. Need to do additional research and coordinate with Sacramento County to confirm crossing location. (O. Magana - DWR UCIP)12/19/2016 bad odor (sewage smell) coming from this area -- potential leak. Unable to confirm if riser on landward side is part of crossing. (O. Magana - DWR UCIP)
FIELD_STRUCT_DESC: [Sacramento County Sanitation District No. 2 Pump Station] 18-inch concrete sewer main through the levee, 8 feet below the crown, 2 feet below the slopes, and approximately 50 feet from the landside (LS) edge. Concrete cutoff wall around the pipe located under the waterside (WS) shoulder. 2-inch air release valve located on the LS slope. Sewage pumping plant on LS. Manhole present. Rock revetment on the WS slope. Crossing continues under the channel and through the opposite levee. (Permit No. 2805, 1958 - Sacramento County Sanitation District No. 2). [Additional Reference(s): DWR Levee Log, 2002].

View of levee crown section near highway.

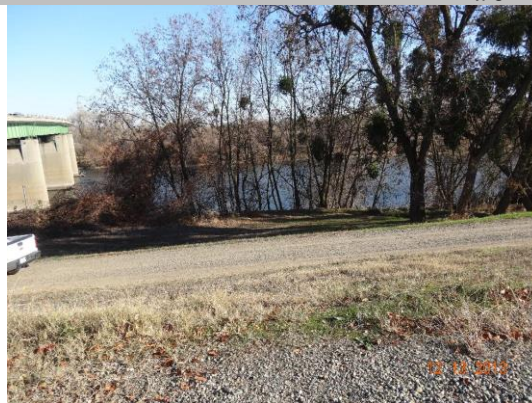
Photo 2 of 3 : UCIP_FA_2018_52708_55291.jpg

View of waterward side.

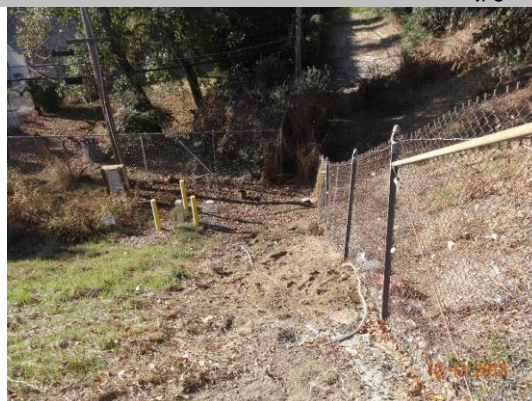
Photo 3 of 3 : UCIP_FA_2018_52708_55295.jpg

FS_ID:52708
DS_ID:24311
EP_NO: 2805
Repair Type: Non-Urgent
Crossing Status: Indicator Found
UCIP Comments: 07/18/2018 Everything appears to be the same as last time. No changes have been made. (A. McDonald - DWR UCIP)08/11/2016 Inspected the crossing with Tim Kerr and Richard Marck, LMA representatives, and it appears that this crossing is not the correct location. The odor could be due to a sewer clean out located on LS toe. Need to do additional research and coordinate with Sacramento County to confirm crossing location. (O. Magana - DWR UCIP)12/19/2016 bad odor (sewage smell) coming from this area -- potential leak. Unable to confirm if riser on landward side is part of crossing. (O. Magana - DWR UCIP)
FIELD_STRUCT_DESC: [Sacramento County Sanitation District No. 2 Pump Station] 18-inch concrete sewer main through the levee, 8 feet below the crown, 2 feet below the slopes, and approximately 50 feet from the landside (LS) edge. Concrete cutoff wall around the pipe located under the waterside (WS) shoulder. 2-inch air release valve located on the LS slope. Sewage pumping plant on LS. Manhole present. Rock revetment on the WS slope. Crossing continues under the channel and through the opposite levee. (Permit No. 2805, 1958 - Sacramento County Sanitation District No. 2). [Additional Reference(s): DWR Levee Log, 2002].

Sewer line along fence line on landward side--riser near back fence.

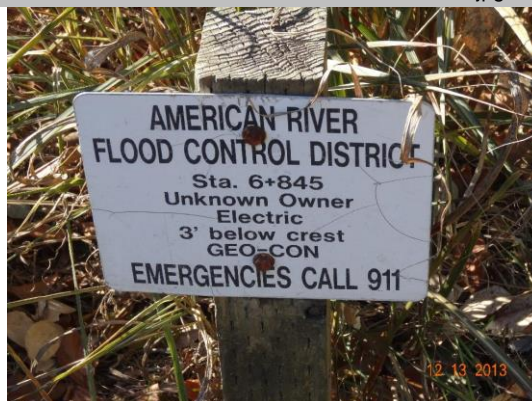
Photo 1 of 3 : UCIP_FA_2018_29054_53588.jpg

LM Start	3.89	Rating **	M	Issue No.	761	
LM End	3.89	Issue Type +	En	Location *		
Category	Supplemental			GPS Latitude/Longitude		
				Start	End	
Item	DWR UCIP Field Study			38.586479°	38.586479°	
				-121.447574°	-121.447574°	
DWR ID	24337					
Comment Code						
Inspector Comment						
FS_ID:29054						
DS_ID:24337						
EP_NO: N/A						
Repair Type: Non-Urgent						
Crossing Status: Found						
UCIP Comments: Unknown owner--Need to coordinate with DWR Inspector and CVFPB.						
FIELD_STRUCT_DESC: 3-inch communication polyvinyl chloride (PVC) conduit through levee, 2 feet below the crown. [Additional Reference(s): DWR Levee Log, 2002]						
FS Date: 12/13/2013

Electrical conduit marker located on landward toe.

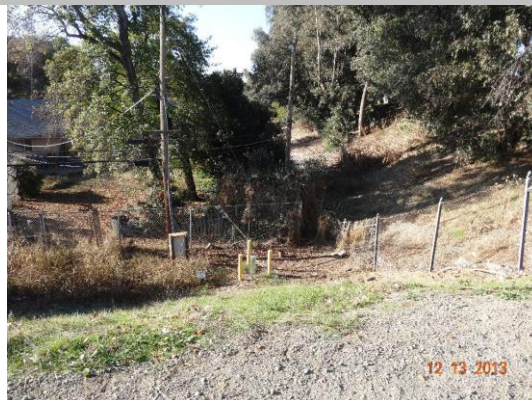
Photo 2 of 3 : UCIP_FA_2018_29054_53587.jpg

View of landward side.

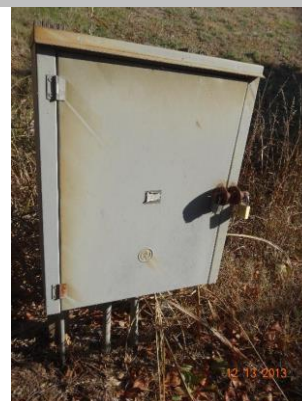
Photo 3 of 3 : UCIP_FA_2018_29054_53589.jpg

LM Start	3.89	Rating **	M	Issue No.	761 (cont)	
LM End	3.89	Issue Type +	En	Location *		
Category	Supplemental			GPS Latitude/Longitude		
				Start	End	
Item	DWR UCIP Field Study			38.586479°	38.586479°	
				-121.447574°	-121.447574°	
DWR ID	24337					
Comment Code						
Inspector Comment						
FS_ID:29054						
DS_ID:24337						
EP_NO: N/A						
Repair Type: Non-Urgent						
Crossing Status: Found						
UCIP Comments: Unknown owner--Need to coordinate with DWR Inspector and CVFPB.						
FIELD_STRUCT_DESC: 3-inch communication polyvinyl chloride (PVC) conduit through levee, 2 feet below the crown. [Additional Reference(s): DWR Levee Log, 2002]						
FS Date: 12/13/2013

Control box located on landward toe.

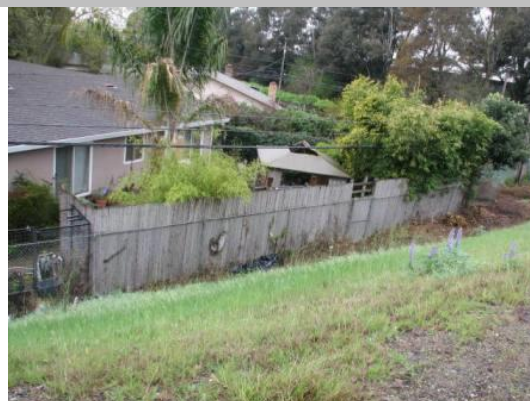
Photo 1 of 2 : FA_2018_NA0001_55_8_20180911_00008.jpg

LM Start	3.90	Rating **	U	Issue No.	8
LM End	3.90	Issue Type +	En	Location *	LS
Category	Earthen Levee			GPS Latitude/Longitude	
				Start	End
Item	Encroachments			38.586327 °	38.586327 °
				-121.447373 °	-121.447373 °
DWR ID	DWR_NA0001_04_s_2012_8				
Comment Code					
FE : Fence					
Inspector Comment					
Bamboo privacy fence within 10-ft of the landside toe obstructs visibility.

03/16/2012 Wood privacy fence completely obstructs access and visibility.

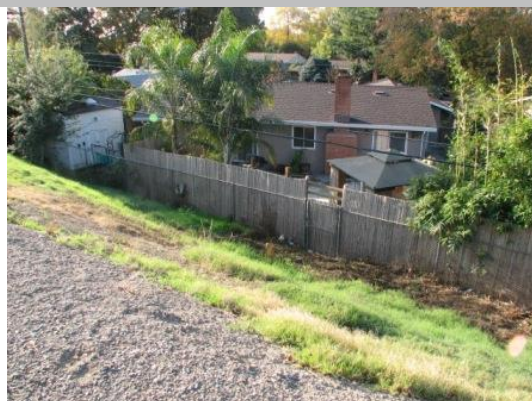
Photo 2 of 2 : FA_2018_NA0001_55_8_20180911_00009.jpg

LM Start	3.90	Rating **	U	Issue No.	8 (cont)	
LM End	3.90	Issue Type +	En	Location *	LS	
Category	Earthen Levee			GPS Latitude/Longitude		
				Start	End	
Item	Encroachments			38.586327 °	38.586327 °	
				-121.447373 °	-121.447373 °	
DWR ID	DWR_NA0001_04_s_2012_8					
Comment Code						
FE : Fence						
Inspector Comment						
Bamboo privacy fence within 10-ft of the landside toe obstructs visibility.

Fall 2009 photo: Fence and landscaping within 10-ft of levee toe obstructs access and visibility.

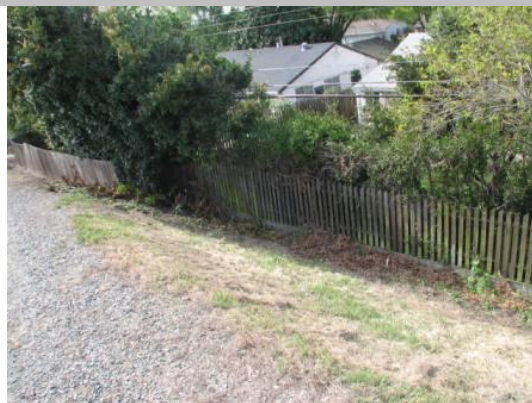
Photo 1 of 1 : FA_2018_NA0001_55_6_20180911_00007.jpg

LM Start	3.92	Rating **	U	Issue No.	6
LM End	3.92	Issue Type +	En	Location *	LS
Category	Earthen Levee			GPS Latitude/Longitude	
				Start	End
Item	Encroachments			38.586154 °	38.586154 °
				-121.447115 °	-121.447115 °
DWR ID	DWR_NA0001_04_s_2012_6				
Comment Code					
FE : Fence					
Inspector Comment					
Privacy fence within 10-ft of the landside toe obstructs visibility.

04/14/2011 Landscaping, which was a Fall inspection issue has been removed; however, wooden fence is still obstructing access and visibility.

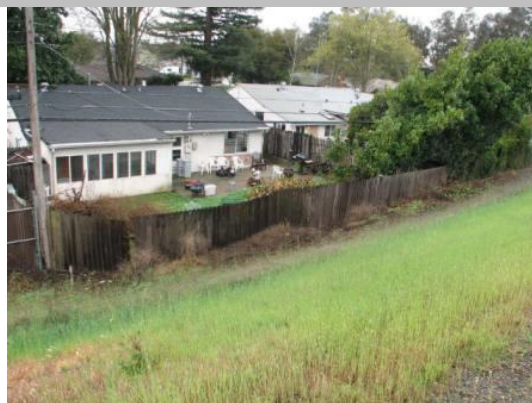
Photo 1 of 1 : FA_2018_NA0001_55_9_20180911_00010.jpg

LM Start	3.93	Rating **	U	Issue No.	9
LM End	3.93	Issue Type +	En	Location *	LS
Category	Earthen Levee			GPS Latitude/Longitude	
				Start	End
Item	Encroachments			38.586047 °	38.586047 °
				-121.446975 °	-121.446975 °
DWR ID	DWR_NA0001_04_s_2012_9				
Comment Code					
FE : Fence					
Inspector Comment					
Wooden privacy fence on the levee slope obstructs access and visibility.

03/16/2012 Wood privacy fence completely obstructs access and visibility.

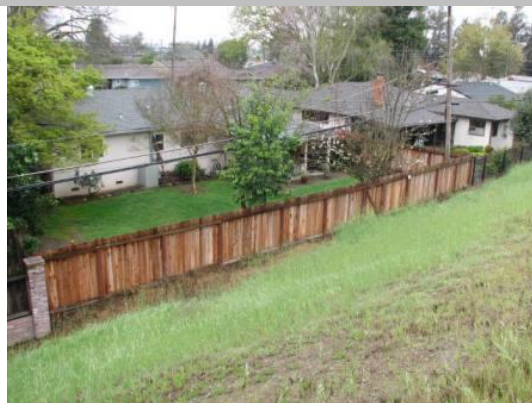
Photo 1 of 1 : FA_2018_NA0001_55_11_20180911_00011.jpg

LM Start	3.97	Rating **	U	Issue No.	11
LM End	3.97	Issue Type +	En	Location *	LS
Category	Earthen Levee			GPS Latitude/Longitude	
				Start	End
Item	Encroachments			38.585639 °	38.585639 °
				-121.446451 °	-121.446451 °
DWR ID	DWR_NA0001_04_s_2012_11				
Comment Code					
FE : Fence					
Inspector Comment					
Privacy fence and landscaping within 10-ft of the levee toe obstruct access and visibility.

03/16/2012 Wood privacy fence completely obstructs access and visibility.

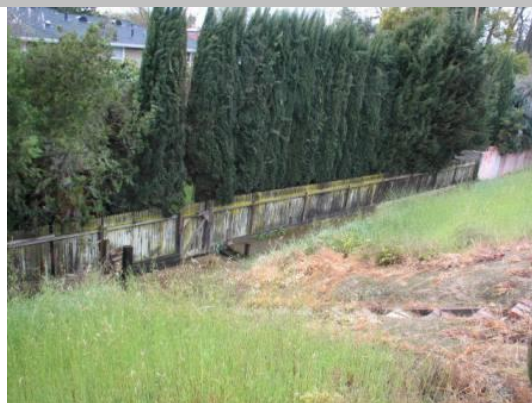
Photo 1 of 1 : FA_2018_NA0001_55_14_20180911_00014.jpg

LM Start	4.02	Rating **	U	Issue No.	14
LM End	4.02	Issue Type +	En	Location *	LS
Category	Earthen Levee			GPS Latitude/Longitude	
				Start	End
Item	Encroachments			38.585175 °	38.585175 °
				-121.445883 °	-121.445883 °
DWR ID	DWR_NA0001_04_s_2012_14				
Comment Code					
FE : Fence					
Inspector Comment					
Privacy fence and helix pencil shrubs planted within 10-ft of the levee toe obstruct access and visibility.

03/16/2012 Wood privacy fence completely obstructs access and visibility.

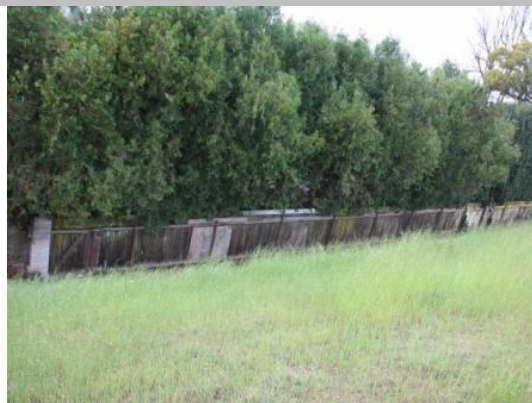
Photo 1 of 1 : FA_2018_NA0001_55_15_20180911_00015.jpg

LM Start	4.03	Rating **	U	Issue No.	15
LM End	4.03	Issue Type +	En	Location *	LS
Category	Earthen Levee			GPS Latitude/Longitude	
				Start	End
Item	Encroachments			38.585021 °	38.585021 °
				-121.445678 °	-121.445678 °
DWR ID	DWR_NA0001_04_s_2012_15				
Comment Code					
FE : Fence					
Inspector Comment					
Privacy fence and evergreen shrub landscaping within 10-ft of the levee toe obstruct access and visibility.

03/16/2012 Wood privacy fence completely obstructs access and visibility.

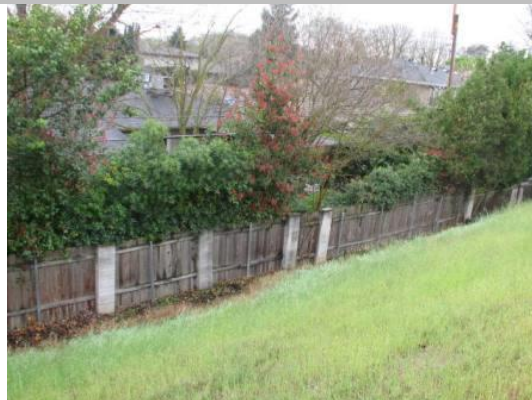
Photo 1 of 1 : FA_2018_NA0001_55_16_20180911_00016.jpg

LM Start	4.04	Rating **	U	Issue No.	16
LM End	4.04	Issue Type +	En	Location *	LS
Category	Earthen Levee			GPS Latitude/Longitude	
				Start	End
Item	Encroachments			38.584885 °	38.584885 °
				-121.445520 °	-121.445520 °
DWR ID	DWR_NA0001_04_s_2012_16				
Comment Code					
FE : Fence					
Inspector Comment					
Privacy fence and landscaping within 10-ft of the levee toe obstruct access and visibility.

03/16/2012 Wood privacy fence completely obstructs access and visibility.

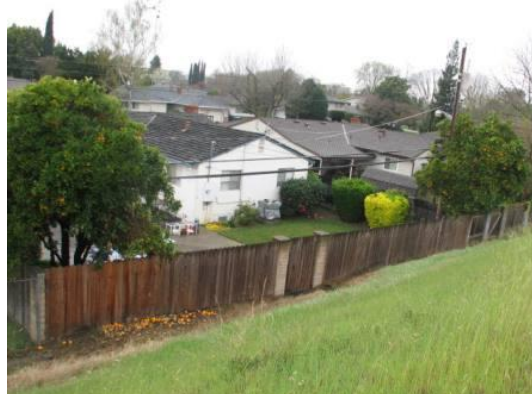
Photo 1 of 1 : FA_2018_NA0001_55_18_20180911_00018.jpg

LM Start	4.06	Rating **	U	Issue No.	18
LM End	4.06	Issue Type +	En	Location *	LS
Category	Earthen Levee			GPS Latitude/Longitude	
				Start	End
Item	Encroachments			38.584694 °	38.584694 °
				-121.445255 °	-121.445255 °
DWR ID	DWR_NA0001_04_s_2012_18				
Comment Code					
FE : Fence					
Inspector Comment					
Wooden fence between orange trees is within 10-ft of the levee toe.

03/16/2012 Wood privacy fence completely obstructs access and visibility.

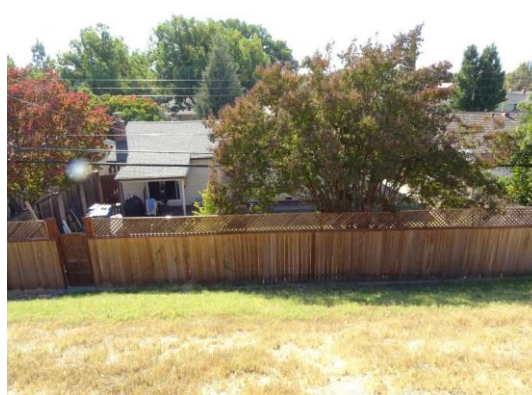
Photo 1 of 1 : FA_2018_NA0001_55_284_20181026_00286.jpg

LM Start	4.08	Rating **	U	Issue No.	284
LM End	4.08	Issue Type +	En	Location *	LS
Category	Earthen Levee			GPS Latitude/Longitude	
				Start	End
Item	Encroachments			38.584556 °	38.584556 °
				-121.445103 °	-121.445103 °
DWR ID	DWR_NA0001_04_f_2018_284				
Comment Code					
FE : Fence					
Inspector Comment					
New wooden fence on levee toe blocks visibility and access.

View of wooden fence on levee toe. Fall 2018

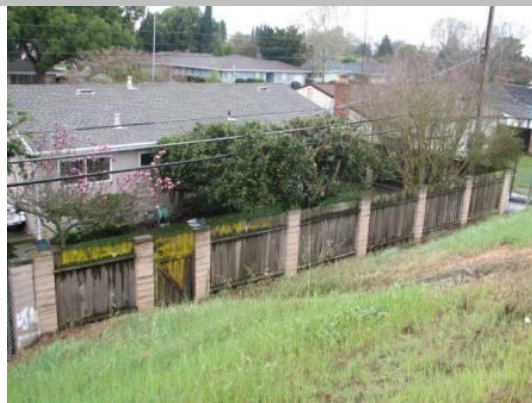
Photo 1 of 1 : FA_2018_NA0001_55_19_20180911_00019.jpg

LM Start	4.09	Rating **	U	Issue No.	19
LM End	4.09	Issue Type +	En	Location *	LS
Category	Earthen Levee			GPS Latitude/Longitude	
				Start	End
Item	Encroachments			38.584459 °	38.584459 °
				-121.444951 °	-121.444951 °
DWR ID	DWR_NA0001_04_s_2012_19				
Comment Code					
FE : Fence					
Inspector Comment					
Privacy fence within 10-ft of the levee toe obstruct access and visibility.

03/16/2012 Wood privacy fence completely obstructs access and visibility.

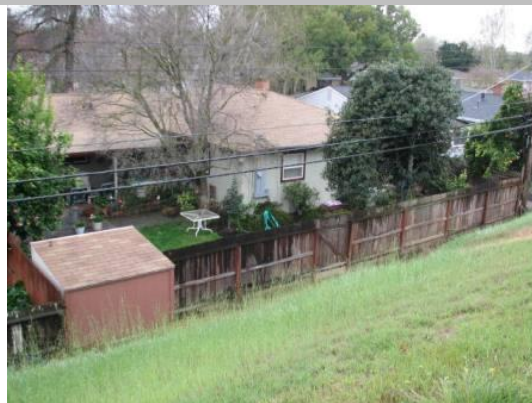
Photo 1 of 1 : FA_2018_NA0001_55_20_20180911_00020.jpg

LM Start	4.11	Rating **	U	Issue No.	20
LM End	4.11	Issue Type +	En	Location *	LS
Category	Earthen Levee			GPS Latitude/Longitude	
				Start	End
Item	Encroachments			38.584243 °	38.584243 °
				-121.444647 °	-121.444647 °
DWR ID	DWR_NA0001_04_s_2012_20				
Comment Code					
FE : Fence					
Inspector Comment					
Privacy fence and shed within 10-ft of the levee toe obstruct access and visibility.

03/16/2012 Wood privacy fence completely obstructs access and visibility.

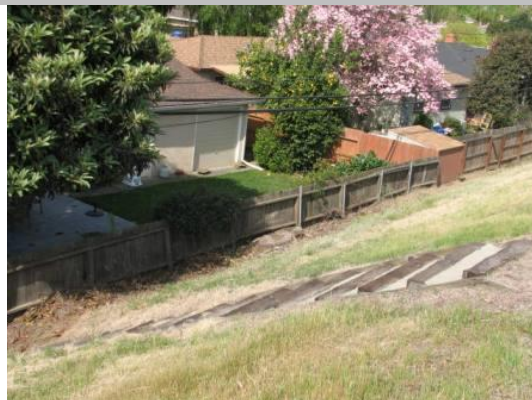
Photo 1 of 1 : FA_2018_NA0001_55_21_20180911_00021.jpg

LM Start	4.12	Rating **	U	Issue No.	21
LM End	4.12	Issue Type +	En	Location *	LS
Category	Earthen Levee			GPS Latitude/Longitude	
				Start	End
Item	Vegetation			38.584129 °	38.584129 °
				-121.444485 °	-121.444485 °
DWR ID	DWR_NA0001_04_s_2012_21				
Comment Code					
V6 : Landscaping					
Inspector Comment					
Other landscaping on levee slope, as well as the wooden privacy fence within 10-ft of the levee toe obstruct access and visibility.

04/14/2011 Palms have been removed.

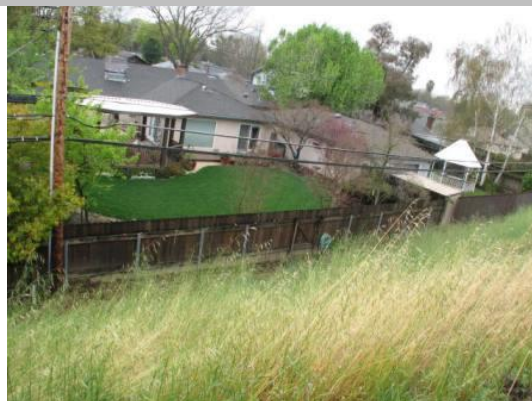
Photo 1 of 1 : FA_2018_NA0001_55_191_20180911_00163.jpg

LM Start	4.21	Rating **	U	Issue No.	191
LM End	4.21	Issue Type +	En	Location *	LS
Category	Earthen Levee			GPS Latitude/Longitude	
				Start	End
Item	Encroachments			38.583355 °	38.583355 °
				-121.443123 °	-121.443123 °
DWR ID	DWR_NA0001_04_s_2012_191				
Comment Code					
FE : Fence					
Inspector Comment					
Wooden privacy fence within 10-ft of the levee toe obstruct access and visibility.

03/16/2012 Wood privacy fence completely obstructs access and visibility.
